# Boat Test

# Outlook 30 Knots - We Get to Thoroughly Thrash

## The Seaforce Fisherman 600

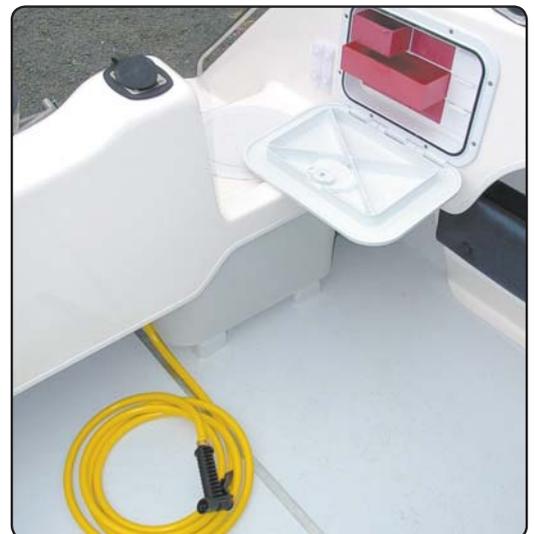
This one is a little different. The port side has a bi-level arrangement. In the front side, angled at the driver, is the VHF. This arrangement works well. The GPS antenna was mounted directly above

the VHF. This is a no-no with a powered antenna (i.e. the antenna is the GPS, not an aerial only) and caused major interference to the VHF to the point that we couldn't leave the GPS on. It will have to be moved. In my opinion, the top level of the port dash needs a fiddle around it to make it a useful space. Anything placed there is only there when the boat isn't moving.

The driver's side works well with a combination sounder/gps and the twin gauge setups now common on Yamaha and Mercury motors. The switch panel is mounted with the fuel gauge on the right hand side on a facing panel. While it's not how I would have designed it, probably because I'm more the traditionalist in these areas, it works well. My only criticism is of the installation of the combo unit. The cable entry isn't sealed and one of the cables disappeared in behind the dash when I disconnected the unit to remove it. A minor problem easily fixed.

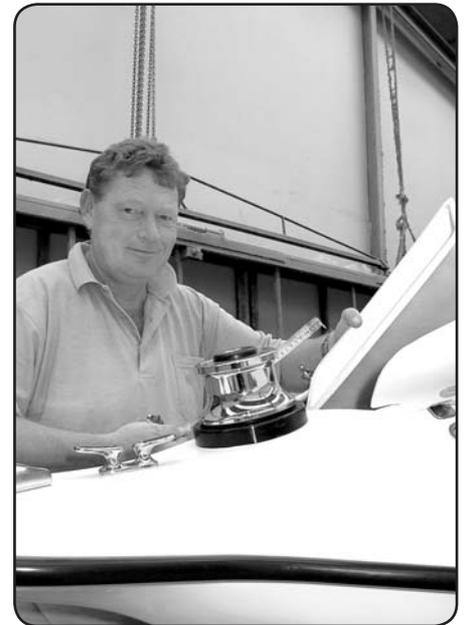
***A week after my test of the boat I went to Seaforce to take a couple of photos in the factory. I found Ric Lawrence already at work making a glass moulding for the winch cover. His dedication to producing the best possible product is very impressive.***
